**AIRCRAFT GROUND-FLOTATION INVESTIGATION**  
**PART XIX. DATA REPORT ON LIGHT-LOAD TRAFFIC TESTS**

**U. S. ARMY ENGINEER WATERWAYS EXPERIMENT STATION**

**TECHNICAL REPORT AFFDL-TR-66-43, PART XIX**

**OCTOBER 1966**

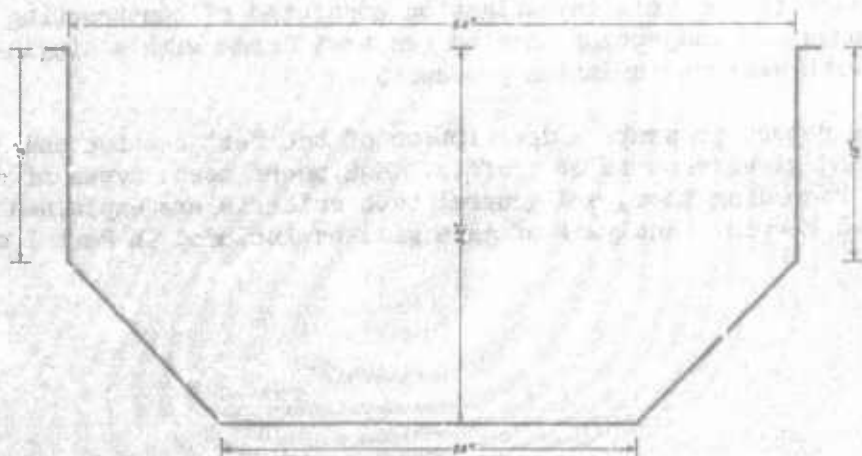
Figure 1. Cross section of soil car

The test lanes were enclosed within a roofed area in order to allow control of the subgrade CBR (California Bearing Ratio). The test lanes were prepared in movable cars constructed of steel plate (figure 4) with a cross-section shape as shown in figure 1. These cars and their associated loading and electronic monitoring and measuring equipment were developed in conjunction with Army Ground Mobility Research being conducted at the WES. Complete description of the facility is not pertinent to this report, but can be found in WES Technical Report No. 3-666.\* Two cars, each 27 ft long with removable end gates, were joined end to end before soil placement was begun to make a test unit. The soil, placed in compacted lifts, was a heavy clay soil (buckshot; classified as CH according to the Unified Soil Classification System, MIL-STD-619). Gradation and classification data for the subgrade material are given in Part I.

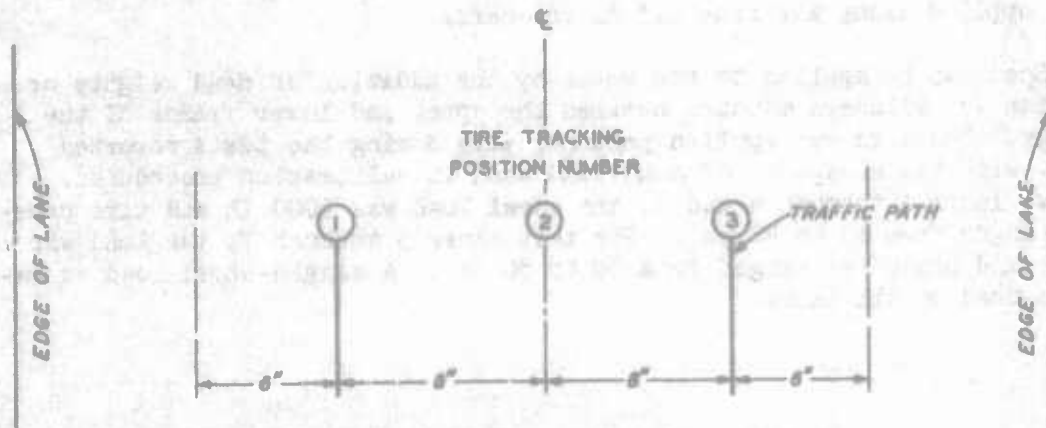
Figure 2. Traffic application pattern

The load vehicle was operated to produce uniform traffic coverage on the center portion of lane 1. Figure 2 shows the general method of applying traffic on lane 1. The dashed lines in the figure represent the center of

tire paths over which 1 pass was applied after each 20 coverages within the main portion of the traffic lane. This infrequent additional traffic was necessary to limit upheaval of soil outside the lane that resulted from traffic within the lane.

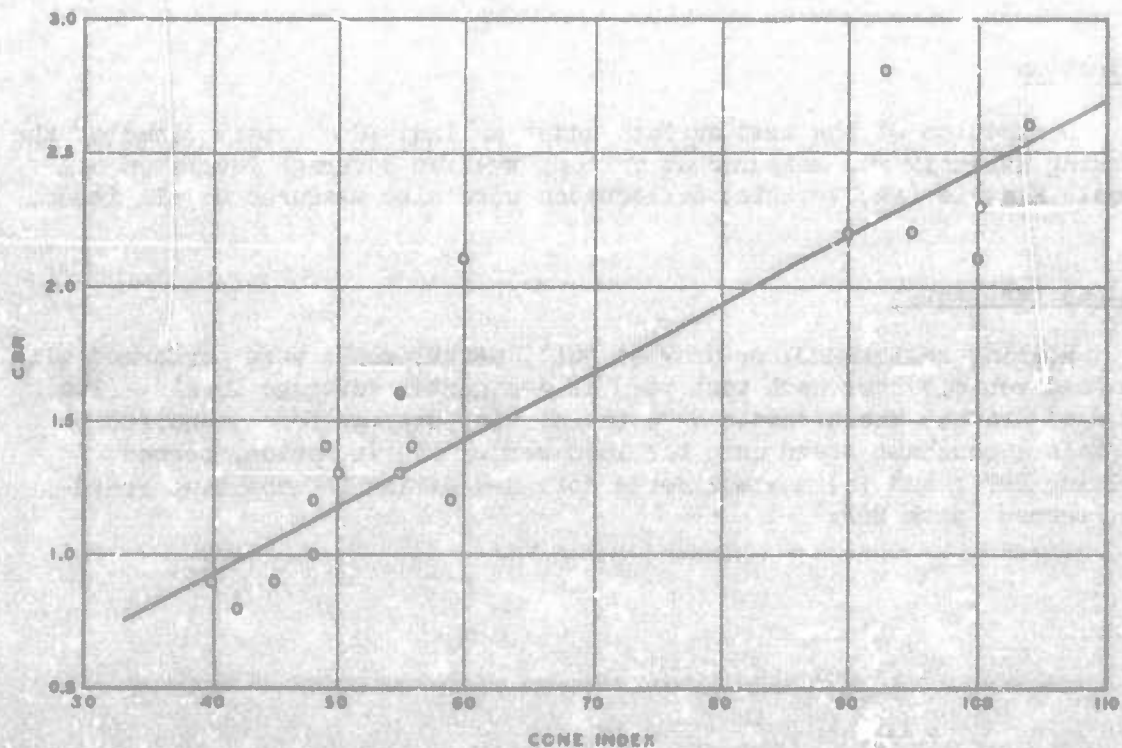
Figure 3. Cone index versus CBR

Cone index is the measurement normally used for strength determinations in the ground mobility facility in which the tests reported herein were conducted, whereas CBR is the strength measurement used in all ground-flotation tests. In the tests reported herein, both cone index and CBR values were obtained for each lane. A correlation of these two measurements was therefore possible. Figure 3 shows the relation between CBR and cone index for this study.

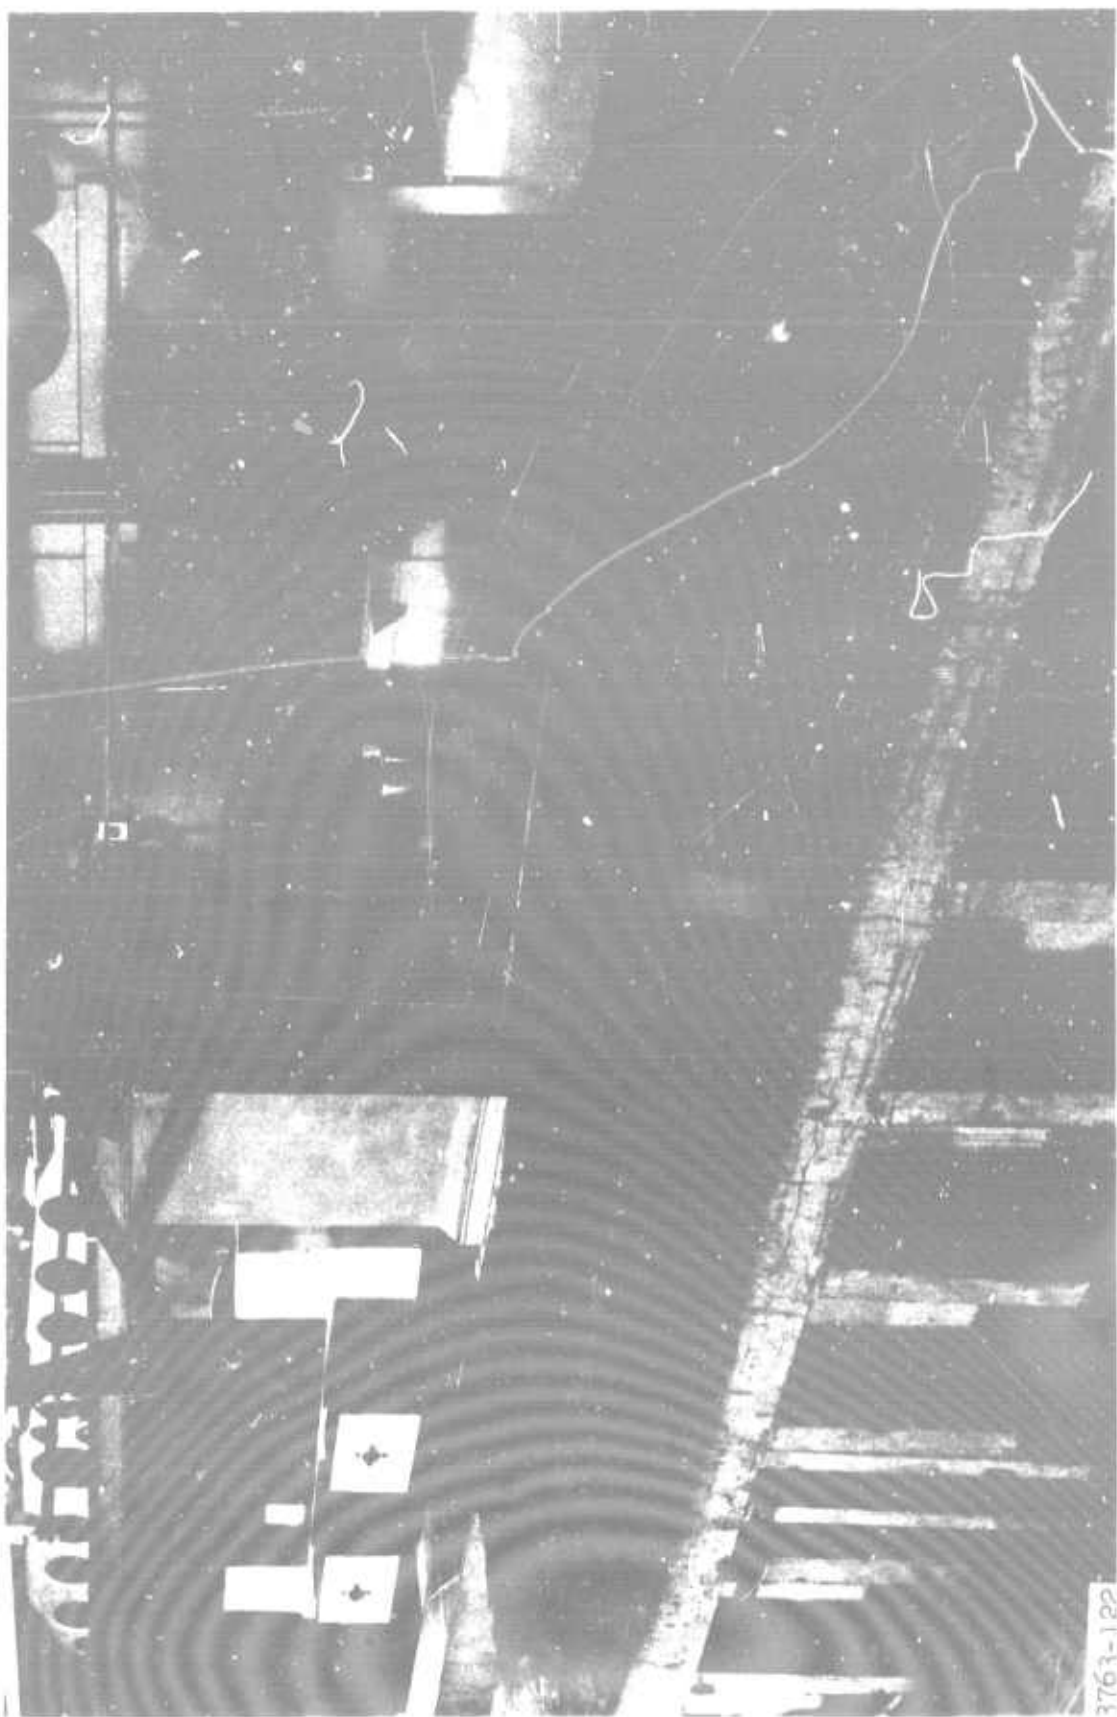
Figure 5. Test carriage over the soil test car

Figure 4 shows the operations area of the test facility. The test carriage is shown in figure 5. The test carriage is supported by

rubber-tired rollers on a pair of accurately aligned and graded overhead rails which are, in turn, suspended from cantilever columns and crossarms in a manner very similar to a typical monorail system. The carriage is towed by an endless steel cable which is fastened, fore and aft, to the carriage, passes over pulleys at the ends of the track system, and is driven by sheaves mounted on a platform above the overhead rails. The speed of the towing cable can be varied continuously from 0 to about 26 ft per sec, and the cable pulleys can be shifted transversely across the width of the soil cars, along with the test carriage, so that the traffic can be applied along any line within the cars.

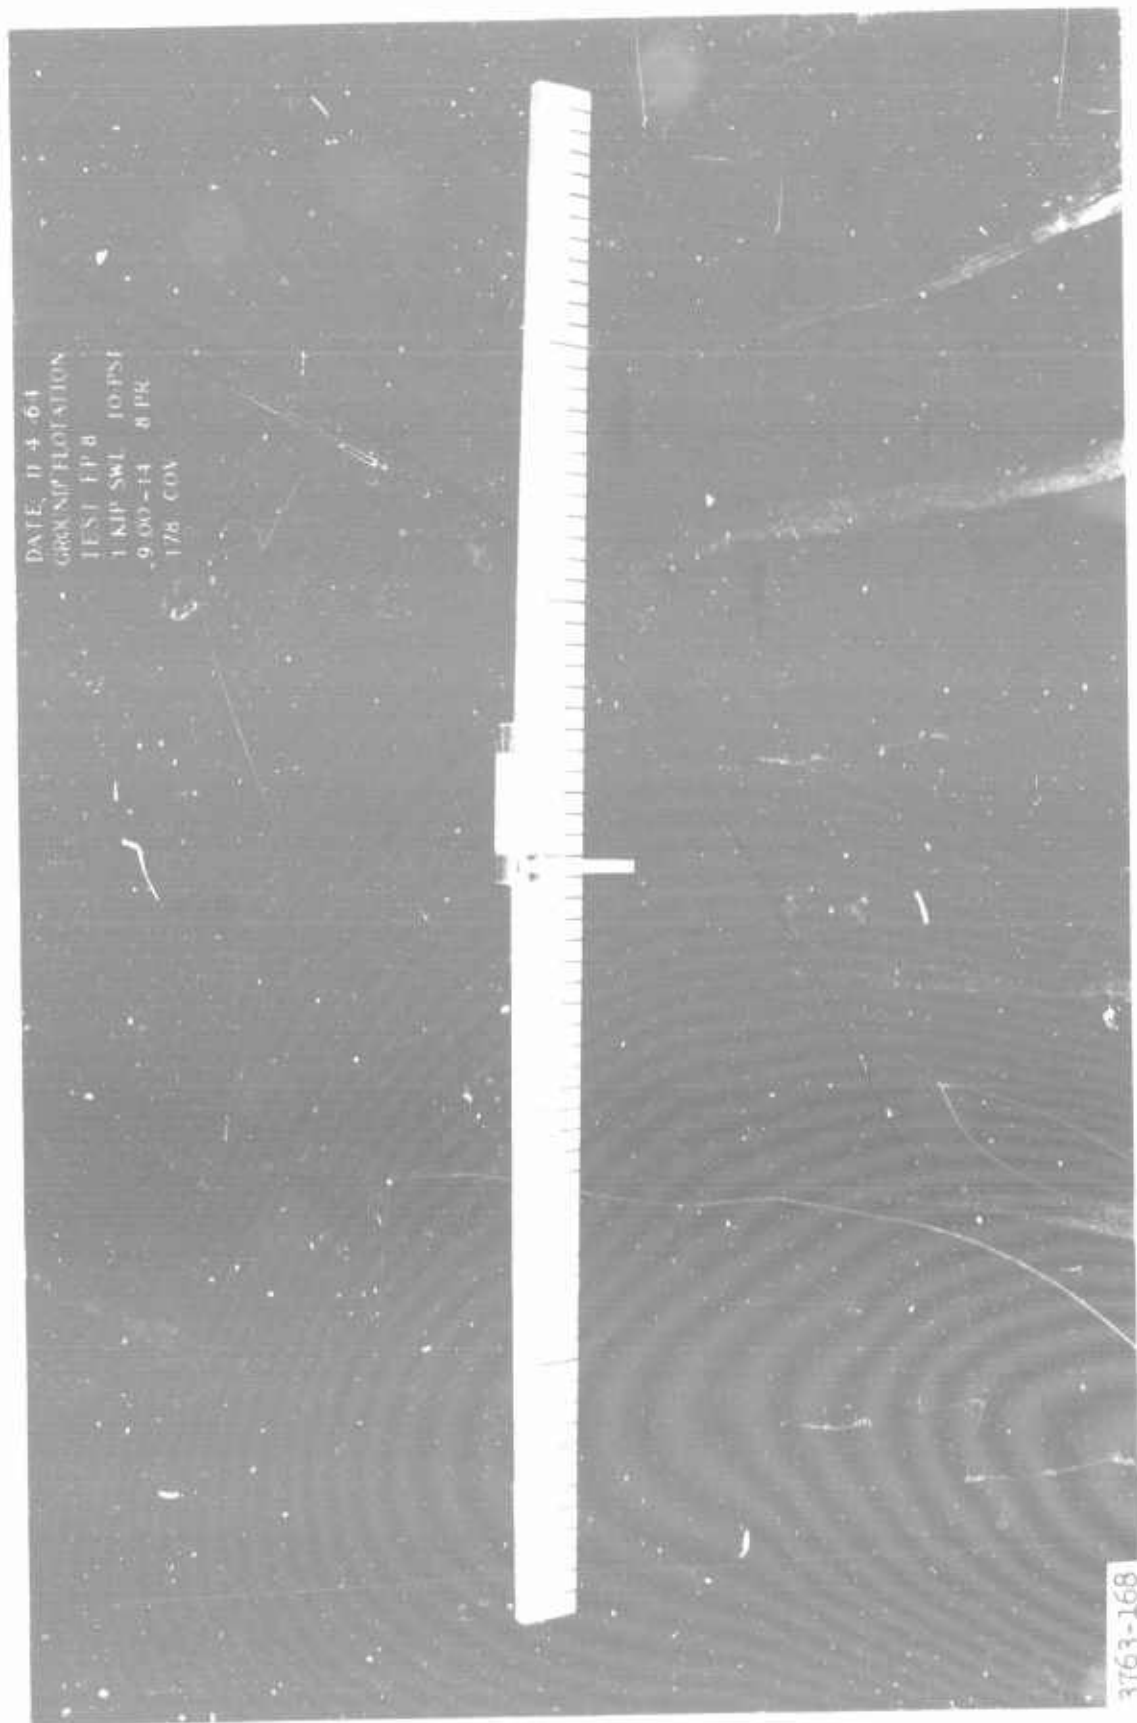
Figure 9. Lane 8 at 178 coverages (failure)

Lane 8 was declared failed at 178 coverages due to excessive rutting and roughness. The rated CBR was 1.1. Figure 9 shows lane 8 at failure.

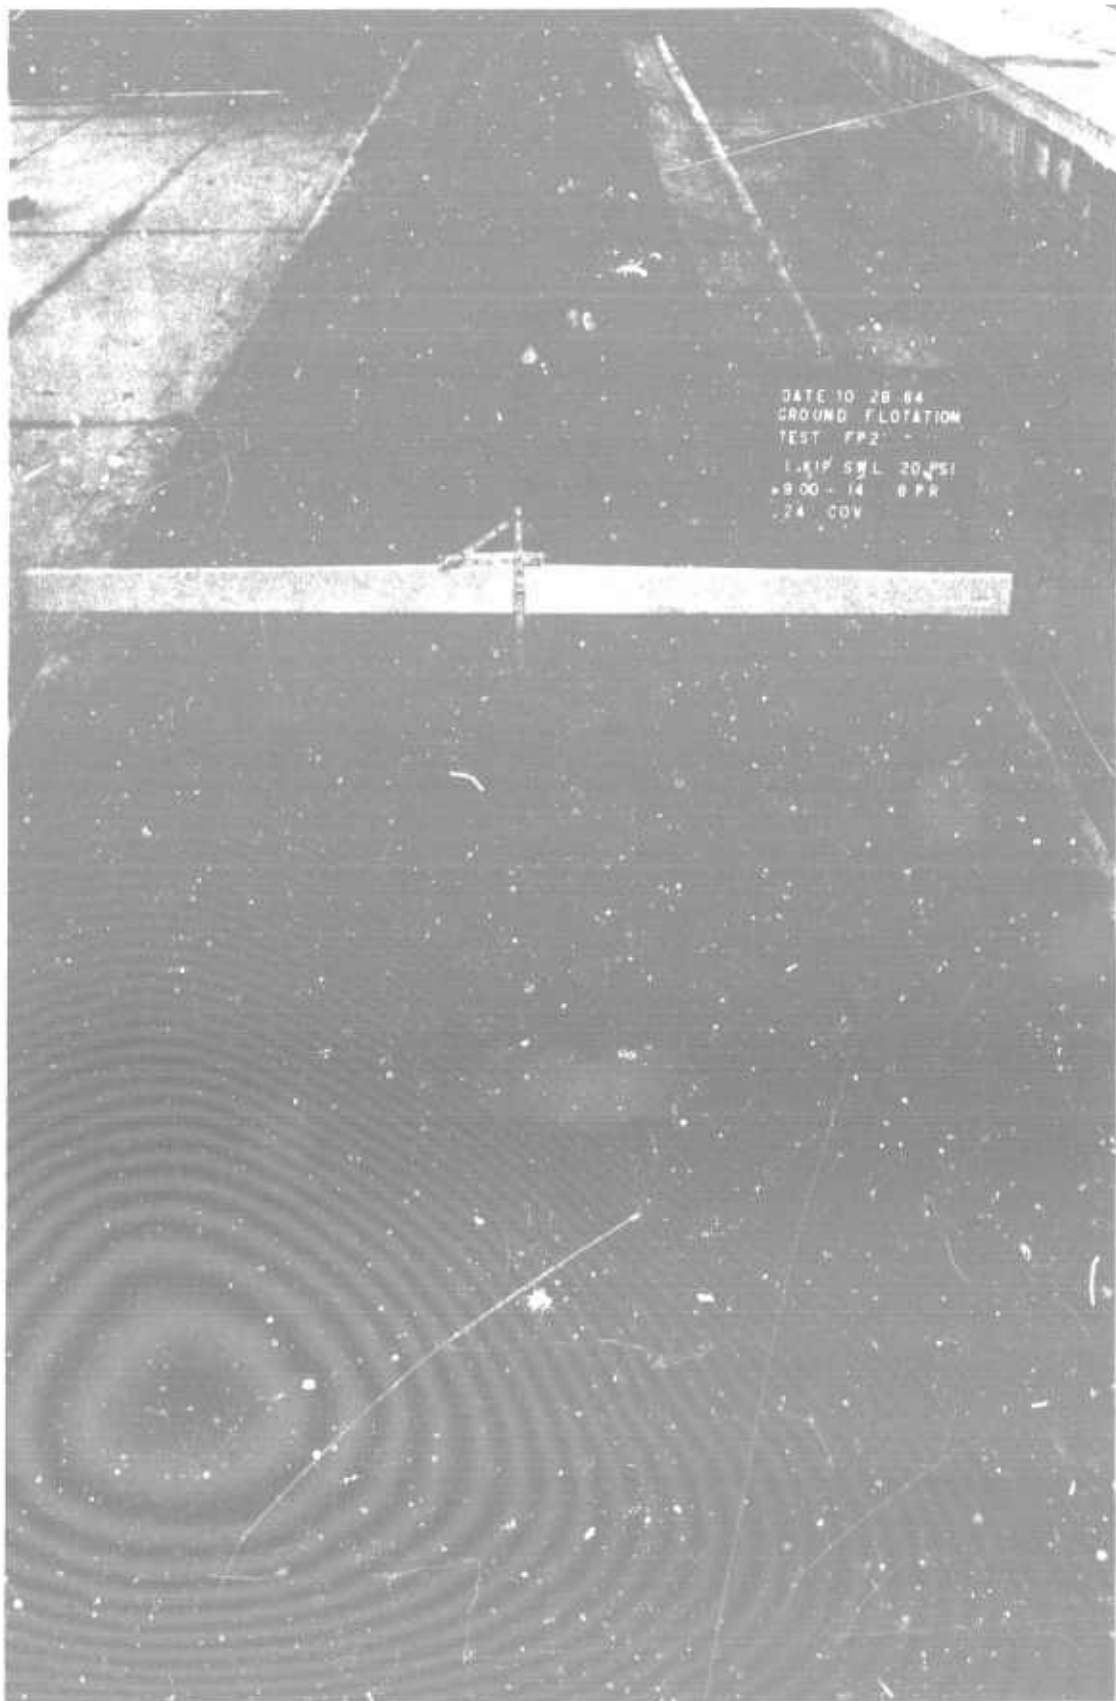
Figure 10. Lane 2 at 24 coverages (failure)

With the increase in tire pressure to 20 psi, more severe deformation resulted. With the application of traffic, soil began to adhere to the tire, making it necessary to remove excessive amounts of clay in order to continue testing. Lane 2 was declared failed at 24 coverages excessive rutting and roughness (figure 10). The rated CBR was

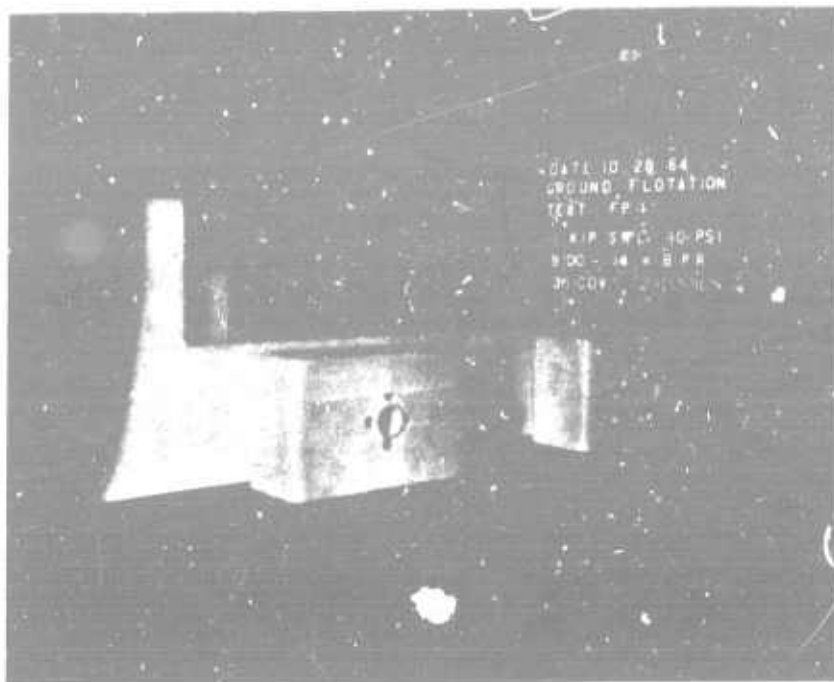
Figure 12. Load wheel showing soil accumulation

Traffic was continued to 24 coverages (figure 11), though failure was declared at 18 coverages due to excessive rutting. The load wheel required cleaning after each two passes following 12 coverages due to soil adhering to the tire as in lane 2. Figure 12 shows a load wheel with an accumulation of soil during testing. The rated CBR was 1.1.

The tire inflation pressure was 40 psi and the rated CBR was 1.2 for lane 4. After 14 coverages, soil began to adhere to the tire (figure 12) and had to be removed periodically. The lane was declared failed at 50 coverages due to excessive rutting (figure 13).

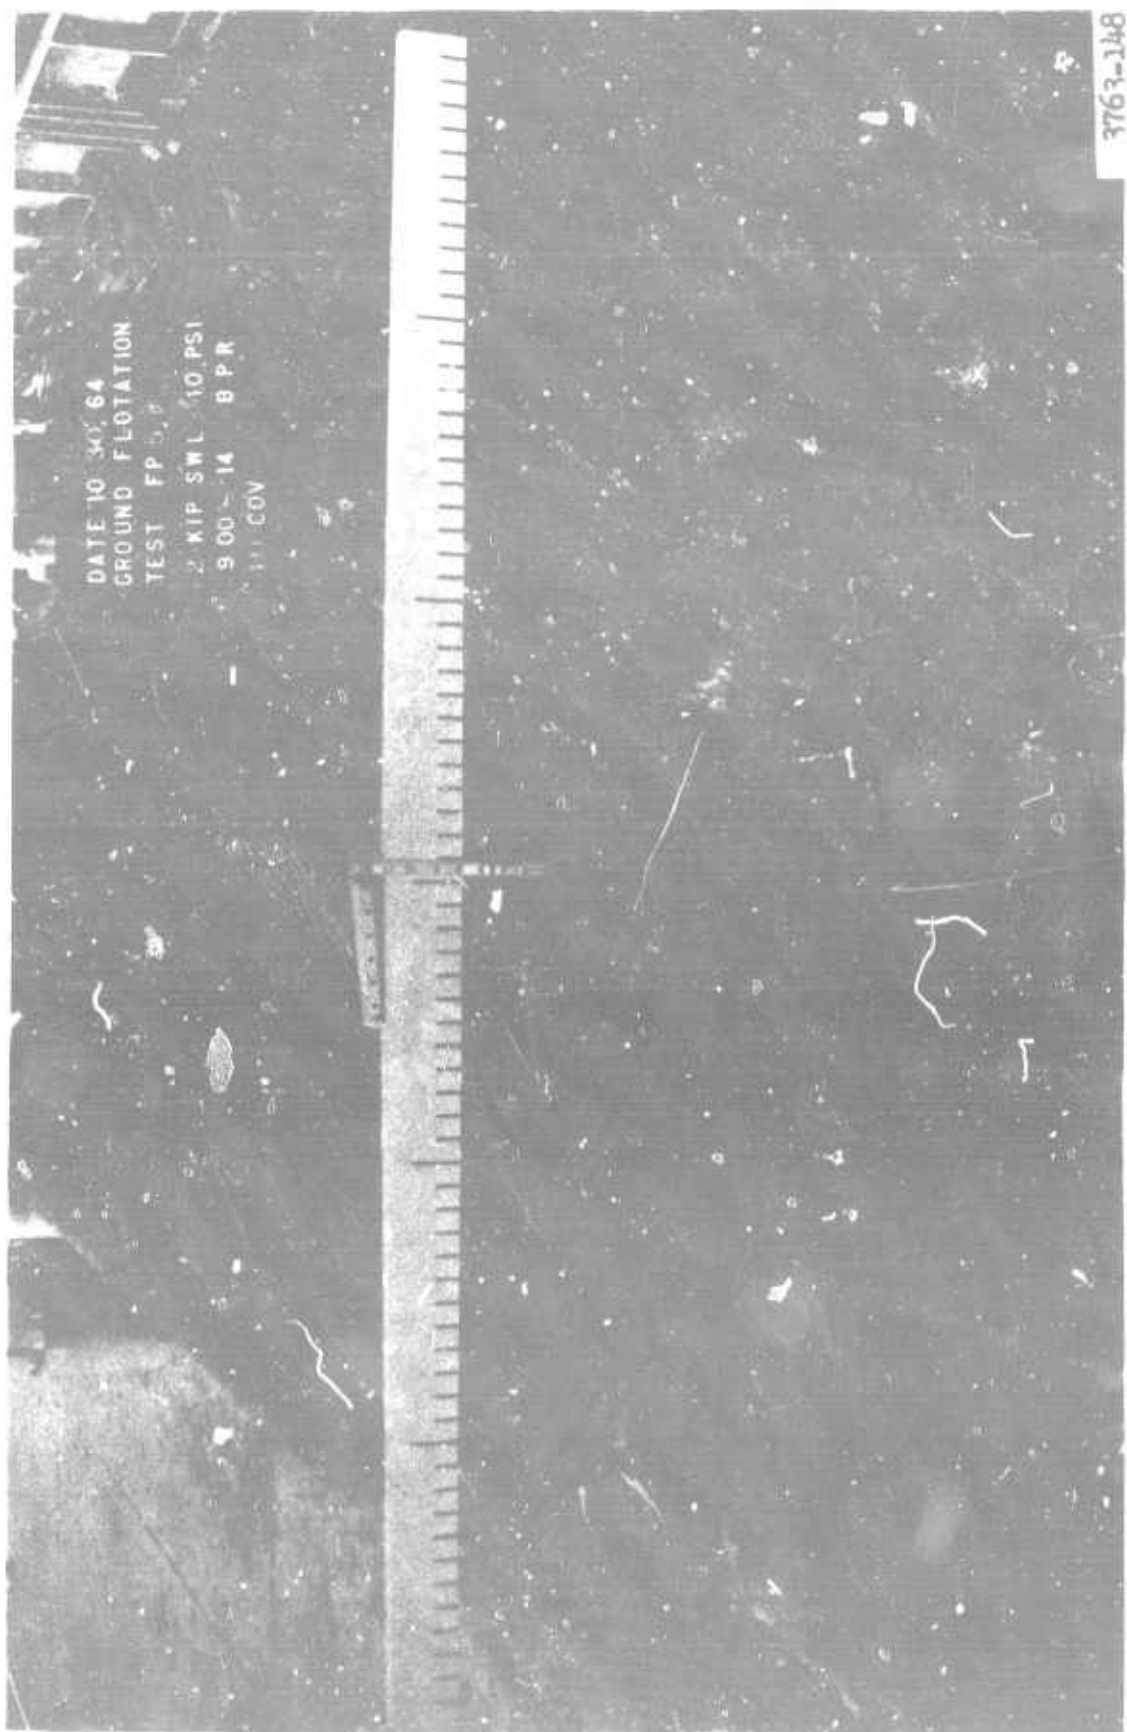
Figure 14. Ler 5 at 40 coverages (two postfailure coverages)

A 2000-lb load and 40-psi inflation pressure were used on a soil with a 2.3 rated CBR in lane 5. The lane was declared failed at 38 coverages due to excessive rutting (figure 14).

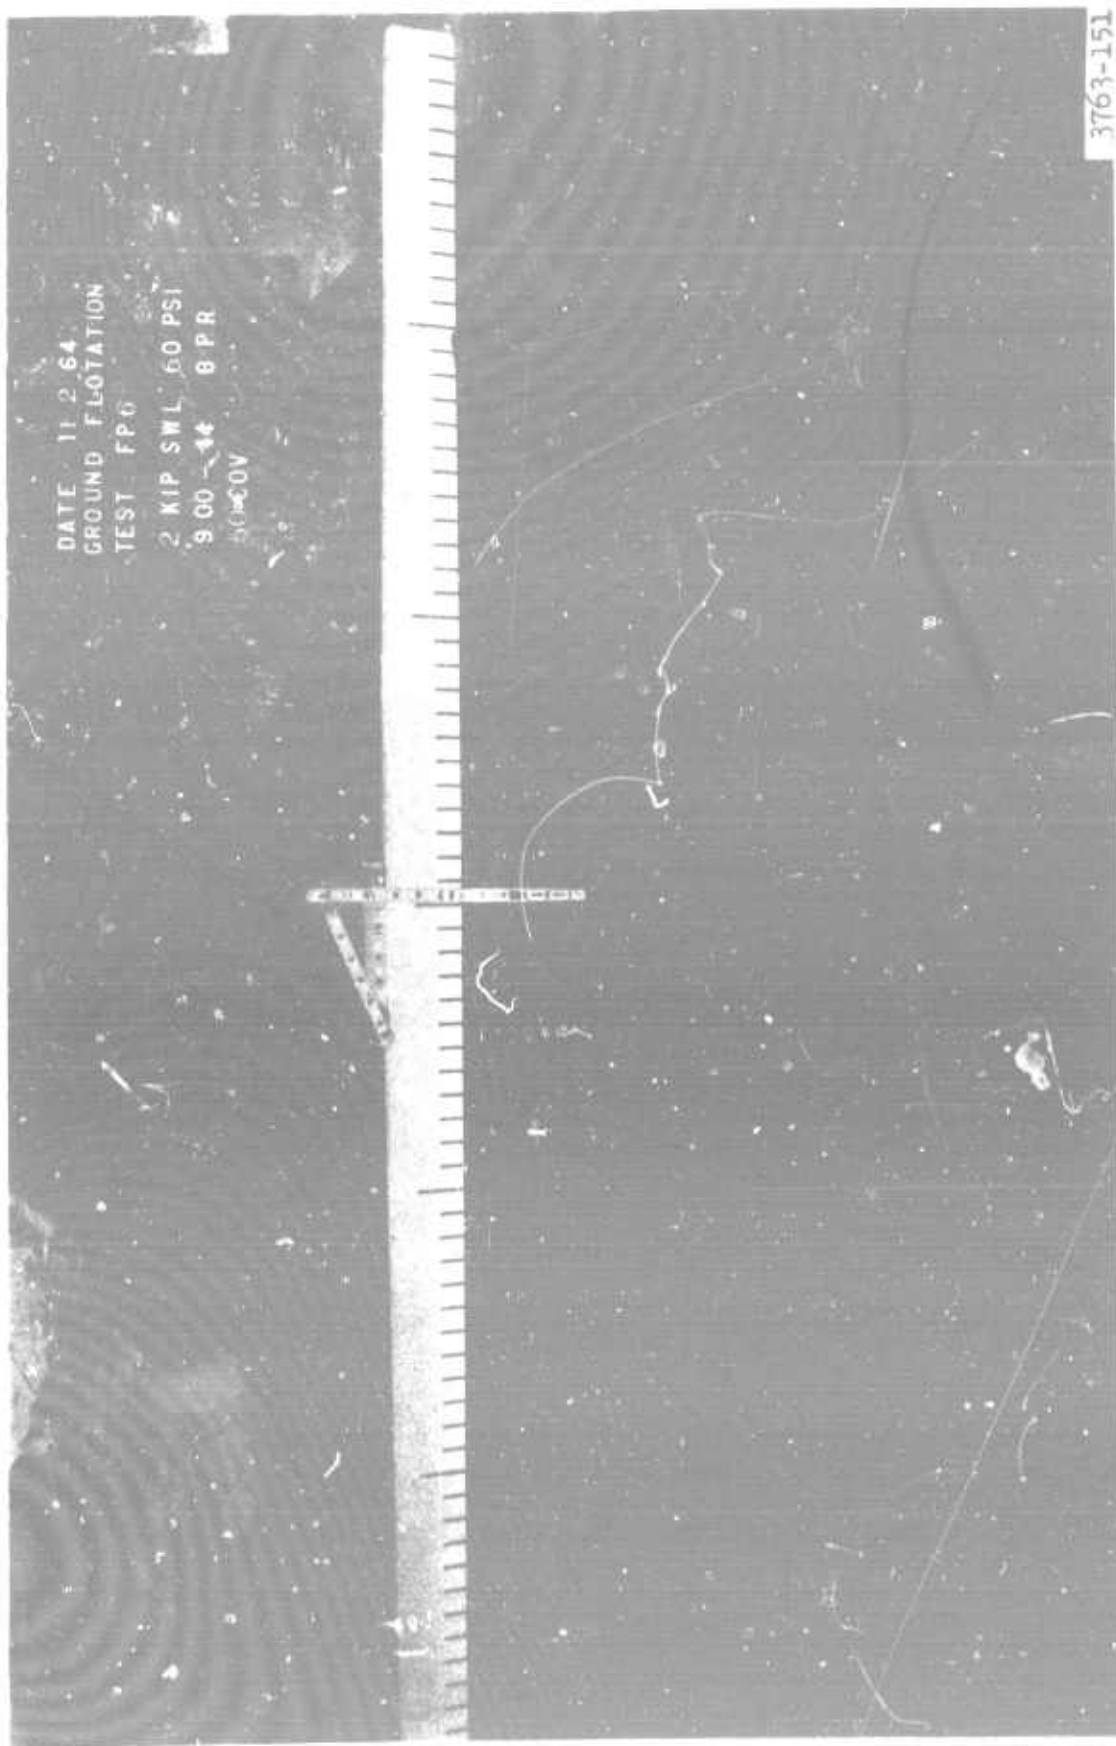
Figure 15. Lane 6 at 50 coverages (failure)

A 2000-lb load and 60-psi inflation pressure were used on a soil with a 2.6 rated CBR in lane 6. The lane was declared failed at 50 coverages due to excessive rutting (figure 15). No unusual behavior occurred.

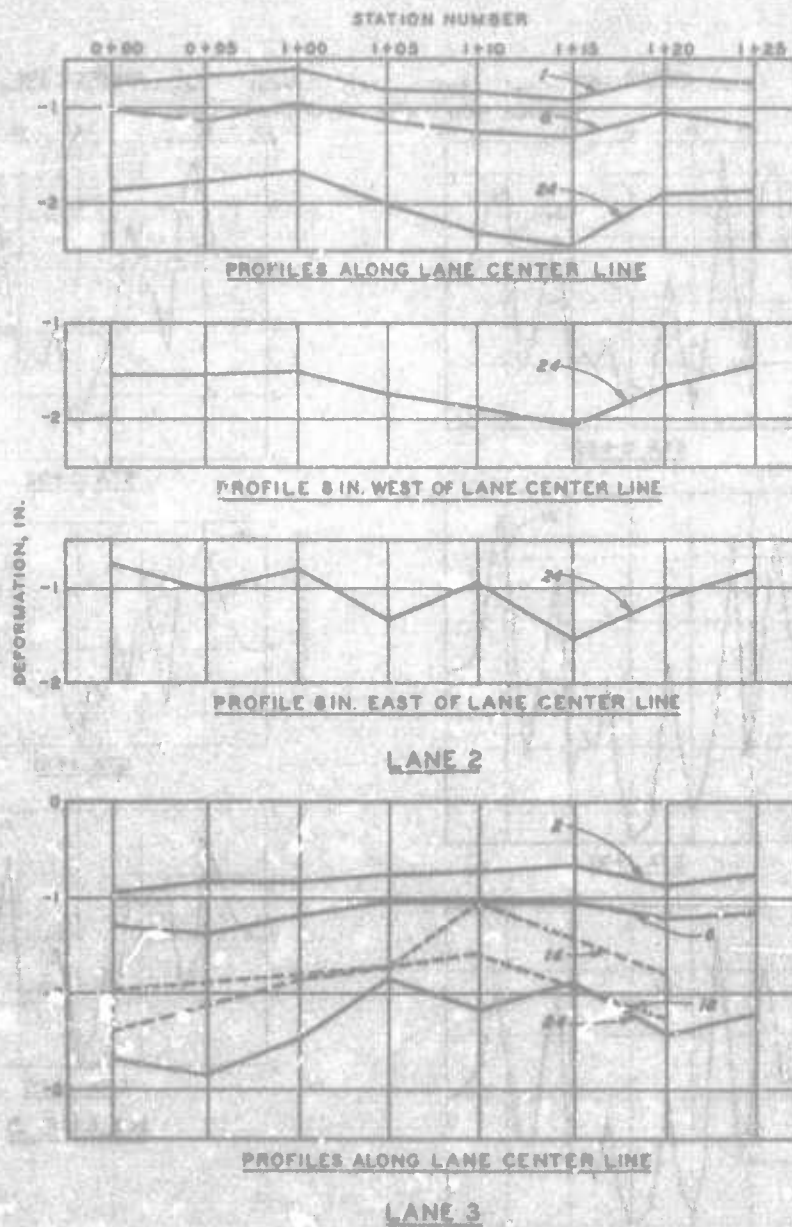
Figure 21

**PERMANENT PROFILE  
 DEFORMATIONS  
 LANES 2 AND 3**

- a. Roughness. The maximum center-line deformation was 2.43 in. at failure (table 1). The maximum transverse departure from a 6-ft straightedge was 4.5 in. and diagonal departure was 3.0 in.
- b. Deformation. Figures 20 and 21 show average cross-section and permanent profile deformations at failure.
- c. Deflections. The elastic soil deflection measured 0.47 in. at failure.
- d. Rolling resistance. Average and peak drawbar pull values were determined at various coverage levels, as shown in table 1.

- a. Roughness. The maximum center-line deformation was 2.36 in. at failure (table 1). The maximum transverse and diagonal departures from a 6-ft straightedge were 5.0 and 4.0 in., respectively, at 24 coverages (six postfailure coverages).
- b. Deformation. Figures 20 and 21 show average cross-section and permanent profile deformations at 24 coverages (six postfailure coverages).
- c. Deflections. The elastic soil deflection was 0.60 in. at 24 coverages (six postfailure coverages).
- d. Rolling resistance. Average and peak drawbar pull values were determined, as shown in table 1.

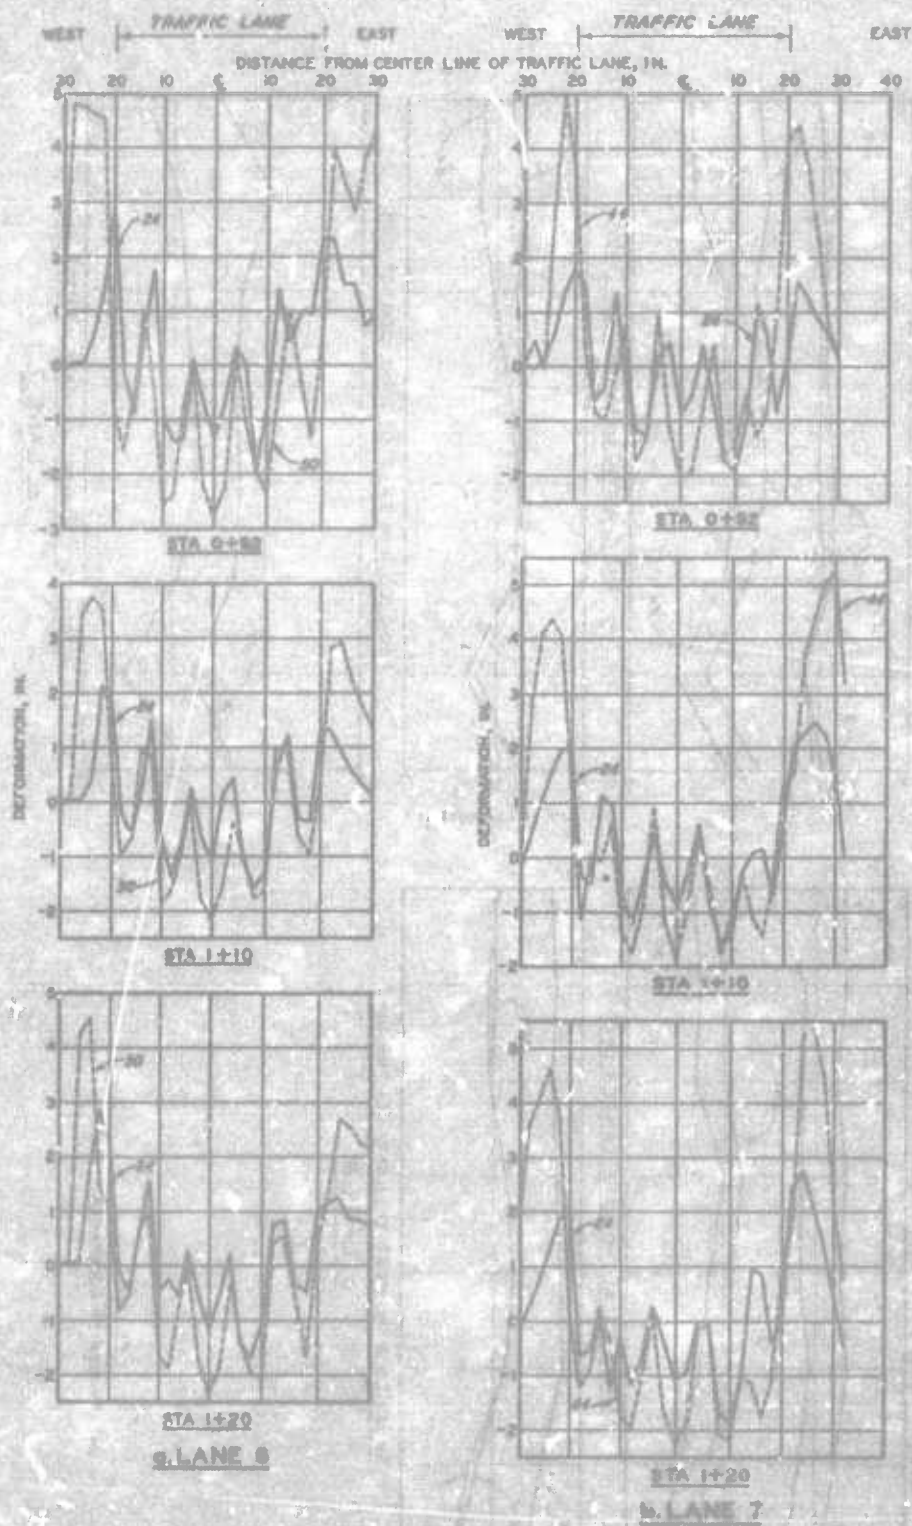
FIGURE 24

CROSS-SECTIONAL  
DEFORMATIONS  
LANES 6 AND 7

- a. Roughness. The maximum center-line deformation was 2.65 in. at failure (table 1). The maximum transverse and diagonal departures from a 6-ft straightedge were 6.0 and 3.5 in., respectively.
- b. Deformation. Figures 24 and 25 show average cross-section and permanent profile deformations at failure.
- c. Deflections. The elastic soil deflection was 0.51 in. at failure.
- d. Rolling resistance. Average and peak drawbar pull values were determined at various coverage levels, as shown in table 1.

- a. Roughness. The maximum center-line deformation was 2.51 in. at failure (table 1). The maximum transverse and diagonal departures from a 6-ft straightedge were 7.0 and 3.8 in., respectively.
- b. Deformation. Figures 24 and 25 show average cross-section and permanent profile deformations at failure.
- c. Deflections. The elastic soil deflection was 0.73 in. at failure.
- d. Rolling resistance. Average and peak drawbar pull values were determined at various coverage levels, as shown in table 1.
